Smoleńsk Maze

**CRASH OF THE POLISH AIR FORCE ONE
SMOLEŃSK, RUSSIA, APRIL 10, 2010**

STATUS REPORT DATED APRIL 2014

MARIA SZONERT BINIENDA

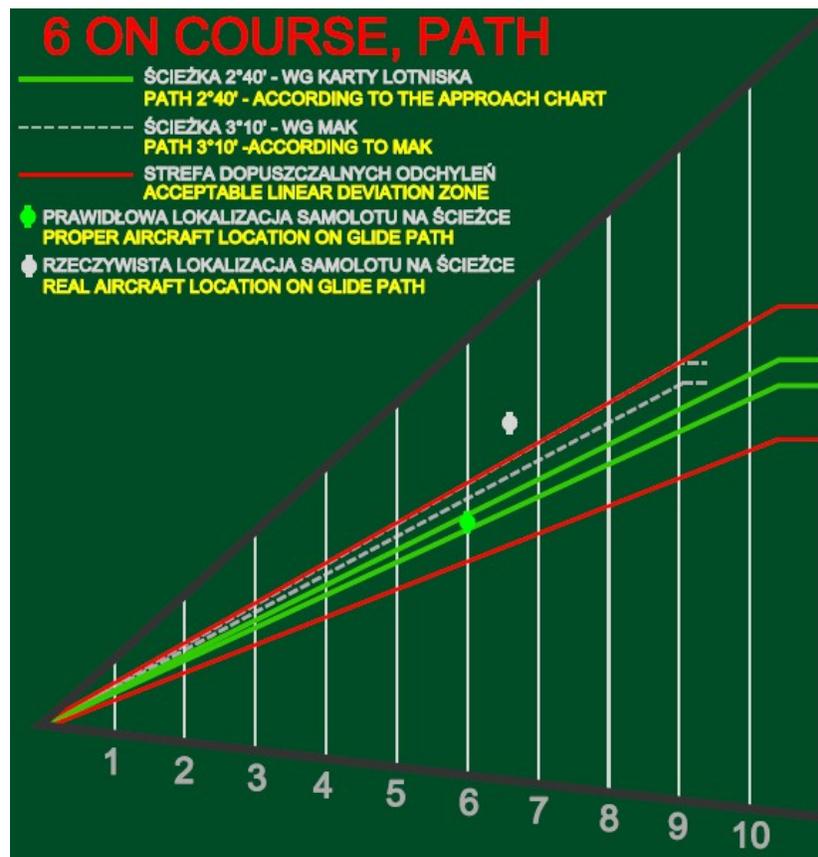
Contrary to the transcript above, the Polish Air Force One in his final approach to the Severny Airport in Smolensk was not on course and was not on a glide path.

[3] The actual position of the Polish Air Force One versus the correct approach path at 6 km before the airdrome. Source: K. Matyszczak

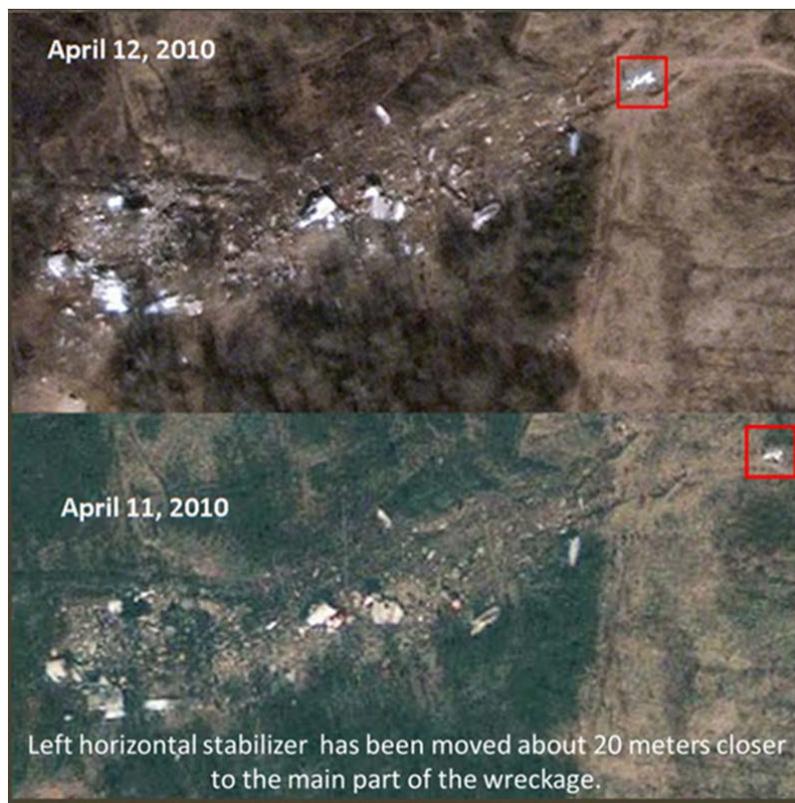
Satellite pictures of the crash site, taken by the GeoEye satellite, demonstrate that the ground position of the plane's left horizontal stabilizer was moved between April 11 and April 12 over 20 meters closer to the first marks on the ground of the wreckage site. The new position from April 12 was considered as the original position in the Russian Report.

[4] Position of left horizontal stabilizer on April 11 vs April 12. Source: K. Nowaczyk.

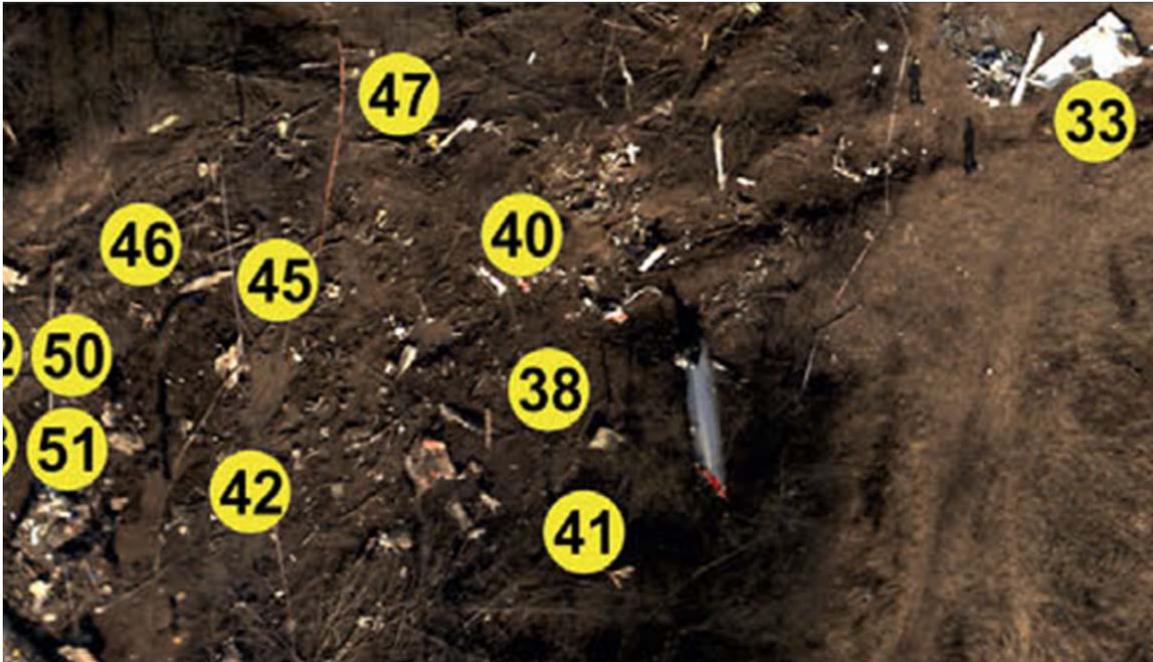
[5] Left stabilizer marked as item 33 in a new position. Source: Figure 35, Russian Report.

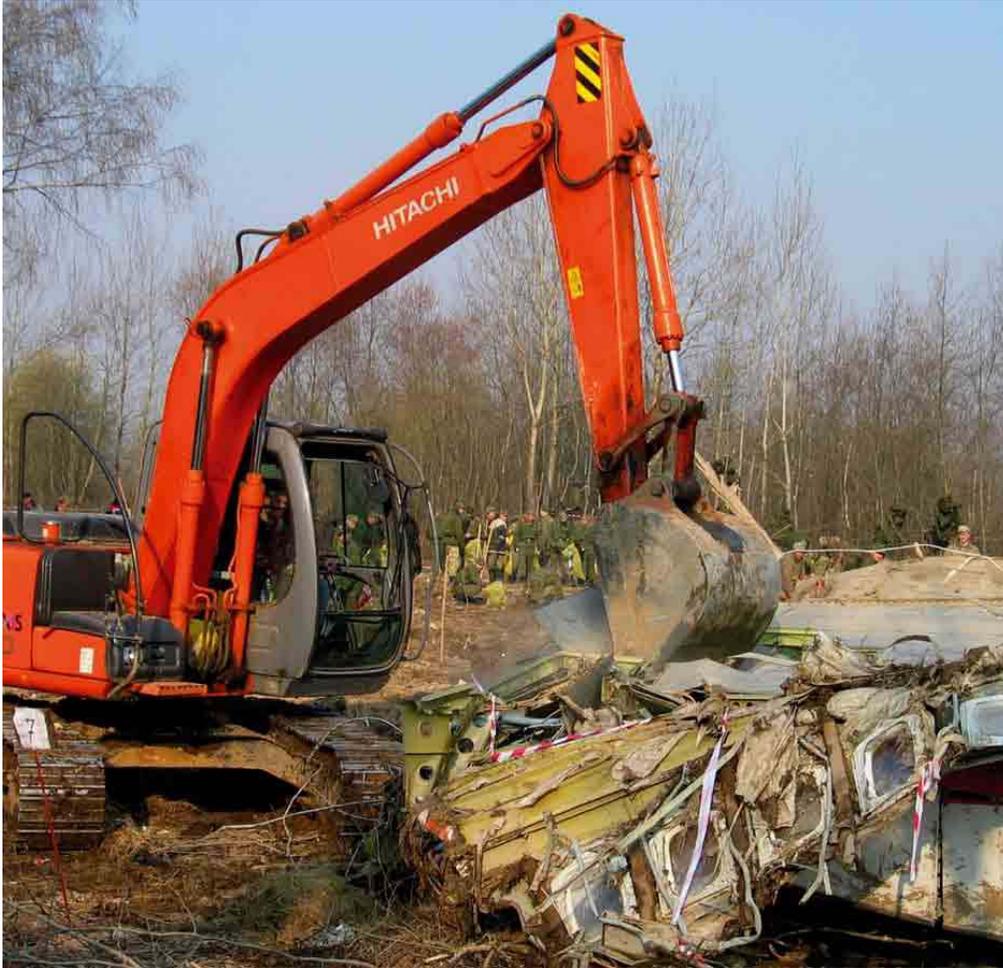
In October 2010, the Polish press published photos showing the process of demolition of the wreckage of the Polish Air Force One at the Severny Airport in Smolensk the next day after the crash. Video footage of the Russian workers destroying the wreckage of the airplane on April 11, 2010, in particular breaking the windows and bulldozing the site, was shown in a documentary “Misja specjalna” by A. Gargas.⁵⁰ Some of the scenes from this video and photographs made by the Polish reporters that day are reproduced below.

[6] Handling of the Wreckage of the Polish Air Force One on April 11, 2010.
Source: J. Gruszczyński

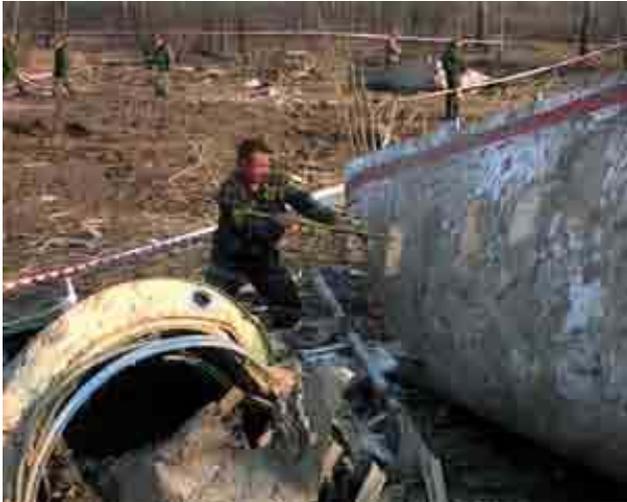
[7] Destruction of windows in the fuselage on April 11, 2010
Source: A. Gargas

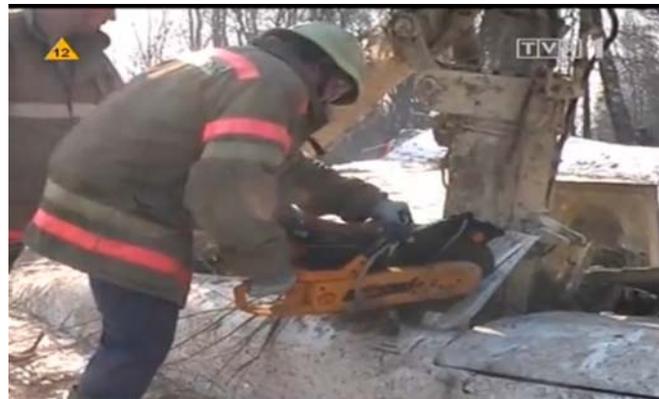
[8] Cutting of the wing, April 11, 2010
Source: A. Gargas

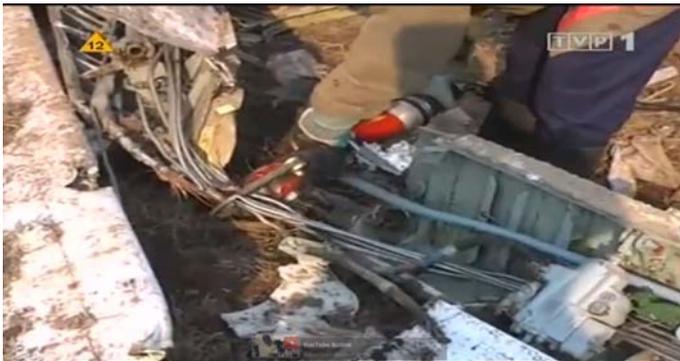
[9] Cutting electric wires, April 11, 2010; Source: A. Gargas

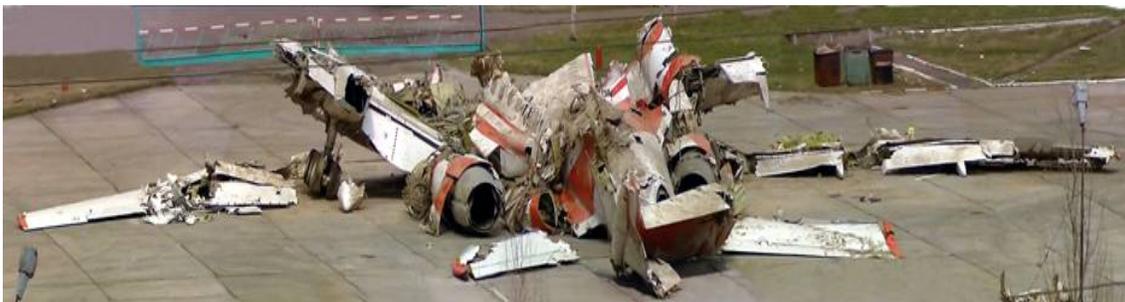
[10] Wreckage of the Polish Air Force One on the pavement of Severny Airport.

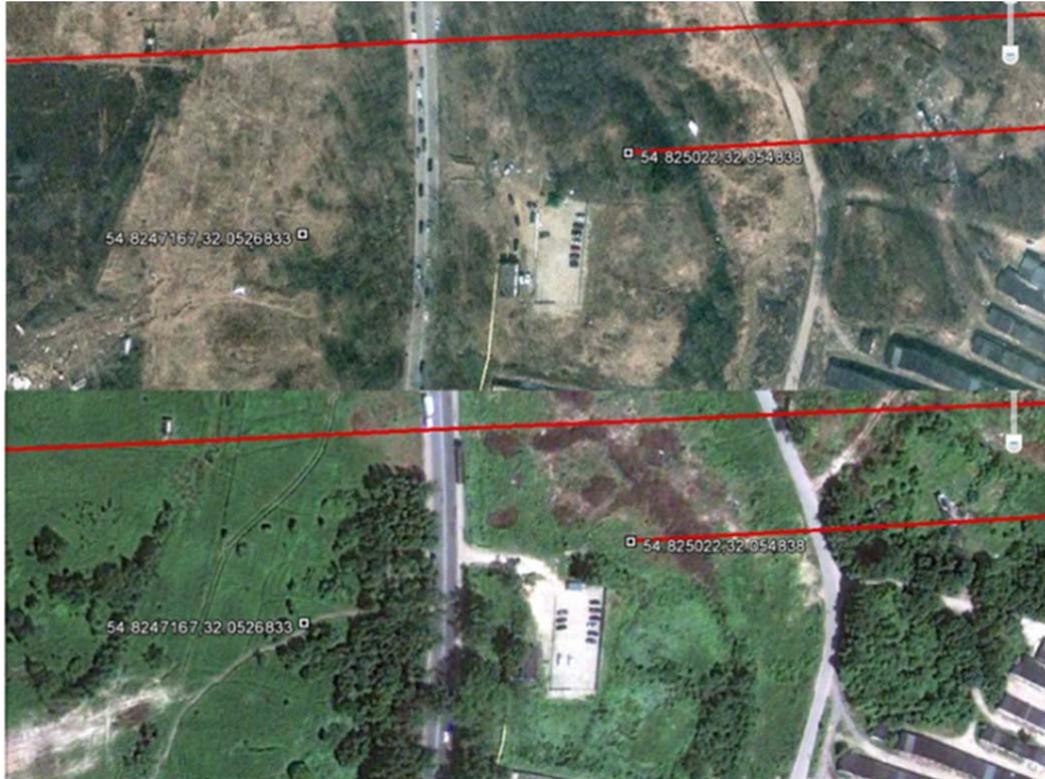
Many trees and shrubs were cut down in the vicinity of the crash site, grass was burnt and top soil was removed, especially near the location of Terrain Awareness and Warning System (TAWS) number 38, which was hidden in the Russian Report.

[11] TAWS #38 area: satellite photo from April 12, 2010 (top) and June 24, 2010 (bottom); the lack of normal growth can be observed on the June photo in the area of TAWS # 38. Source: K. Nowaczvk

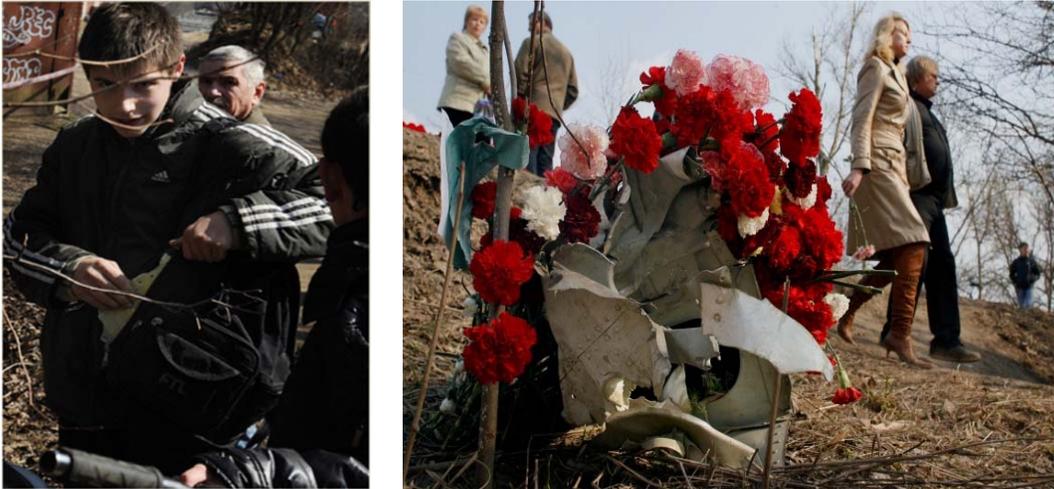
[12] Crash Site Unprotected; Source: K. Nowaczyk

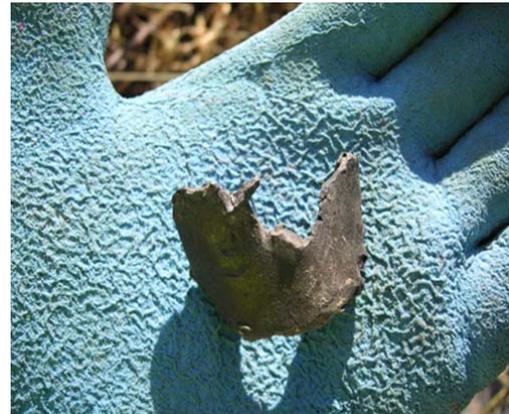
Six months after the crash, a team of Polish archeologists was finally allowed to examine the crash site. The Polish experts found ten thousand small pieces of debris on the surface, including 28 pieces of human remains, and identified with metal detectors sensing up to 20 cm deep another twenty thousand fragments of metal pieces hidden in the soil up to 20 cm deep. Using several drills, they confirmed that near the location of every small metal fragment there were on average another six non-metal fragments. Some metal fragments were exposed to high temperature. The large number of small debris and characteristics of the debris are typical to explosion.⁵⁴

[13] Example of a piece of debris found before the main crash site by Polish archeologists 6 months after the crash.

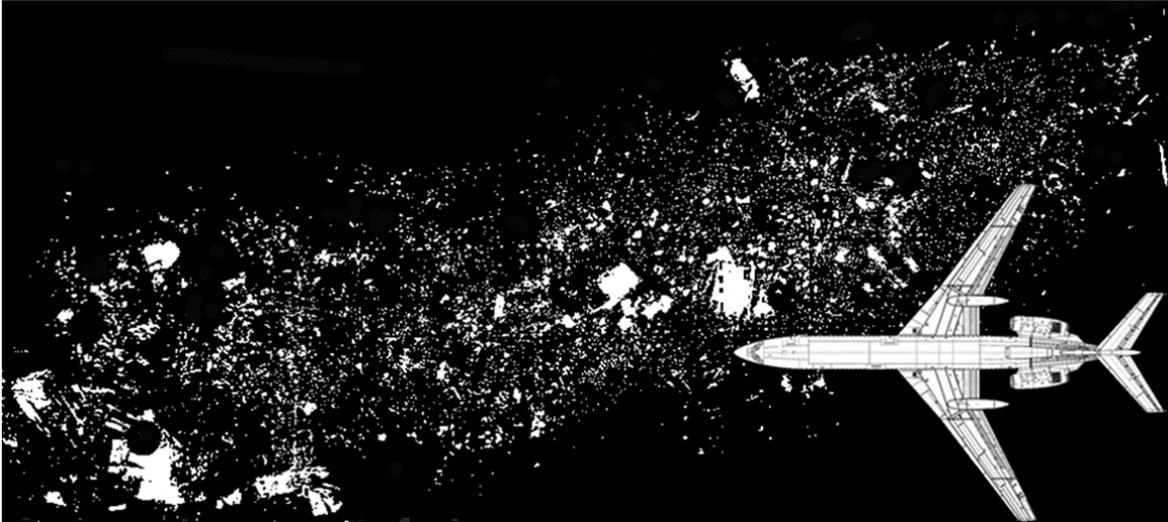
[14] Map of debris found on the main crash site reconstructed from the Polish Archeologists Report. Source: Smolensk Report 2013, Visualization by K. Nowaczyk.

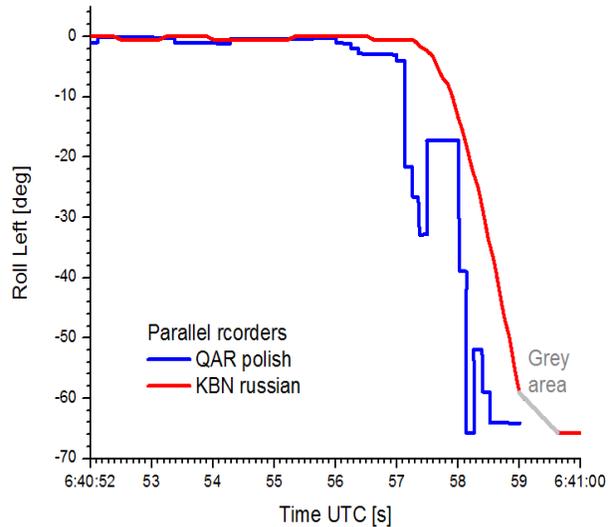
The grey area at the bottom of the graph in Figure 15 indicates a place where the Russian analytic program WinArc32 used by IAC removed “uncertainly” data points.

[15]. Recorded left roll from parallel recorders. Source: K. Nowaczyk

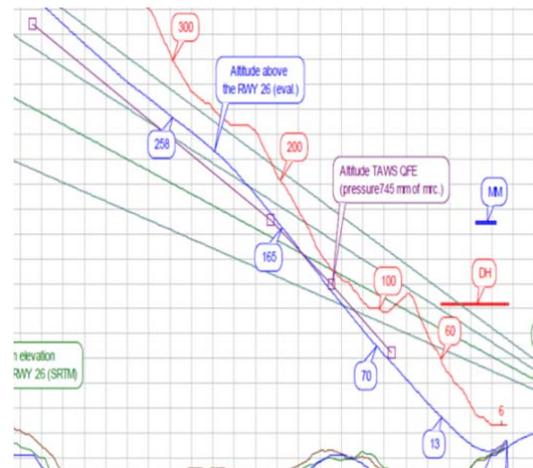
The Russian Report omits TAWS #38 event landing completely. See Figure 16.⁶⁵ The blue line (TAWS baro-altitude) does not contain any explicit information from TAWS #38 or any of the FMS logs. The last mark on the blue line indicates TAWS #37.

[16] No TAWS 38 in the Russian Report

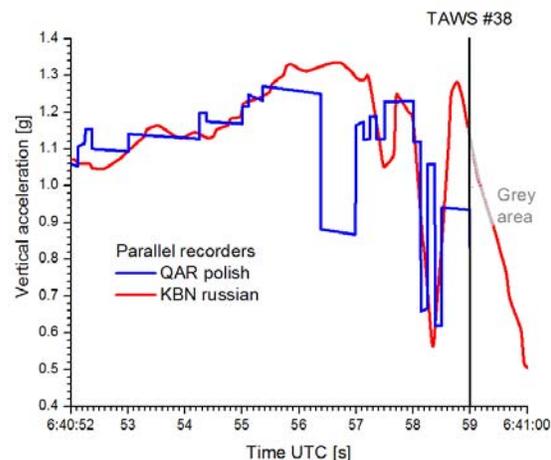
Figure 17 shows a vertical acceleration chart from the Russian Report (red line),⁶⁶ and the same data from the Polish QAR recorder (blue line). Both graphs show two peaks occurring in very fast succession, on the order of one tenth of a second, before TAWS #38, around 200 m before crash site. These strong changes of acceleration have been caused by a powerful downward-acting force but are not explained in the Russian Report.

[17] Vertical acceleration from Russian and Polish black boxes. Source: K. Nowaczyk

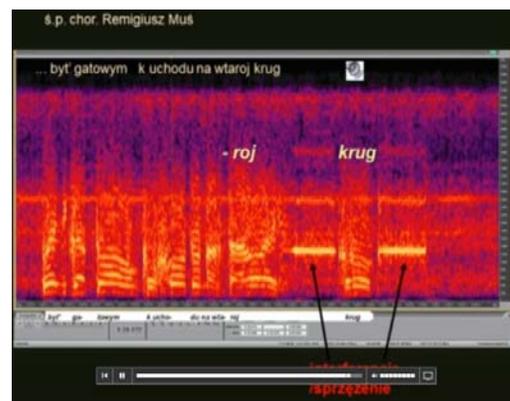
Numerous problems have been raised in connection with the acoustic reading of the flight data recorders. The problems range from different lengths of the same recording, the lack of professional analysis of acoustic image of the recording, incorrect read-out and interpretation of the recordings to fundamental problem with the reliability and integrity of the flight data recordings. As demonstrated by Dr. Gruszczyńska

[18] Acoustic Analysis of FDR;
Source: A. Gruszczyńska-Ziółkowska

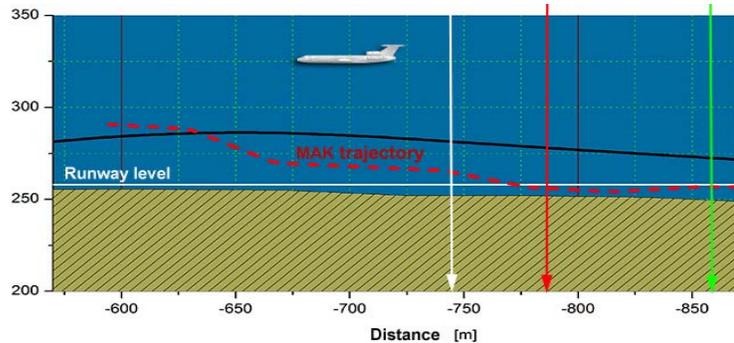
**Vertical and horizontal trajectory presented by the Russians is wrong;
(K. Nowaczyk, G. Jorgensen,) 73**

[19] Russian trajectory vs. TAWS trajectory; Source: K. Nowaczyk

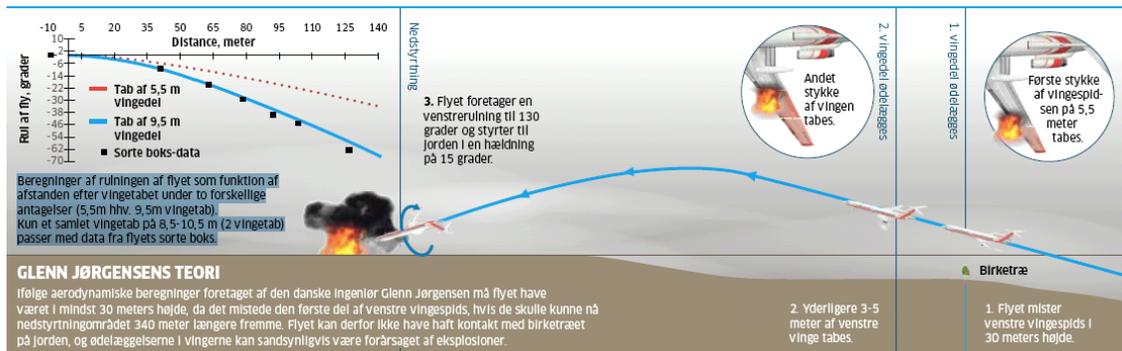
[20] Danish Engineer G. Jorgensen Rejects Russian Trajectory; Source: Ingenioren, 02. 21. 2014.

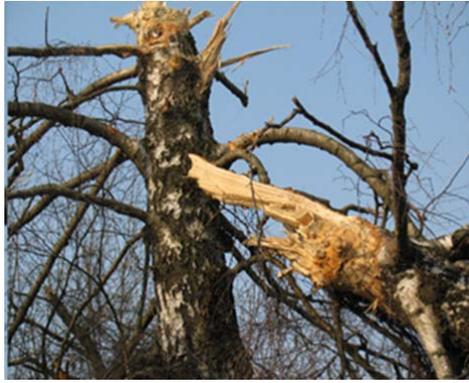
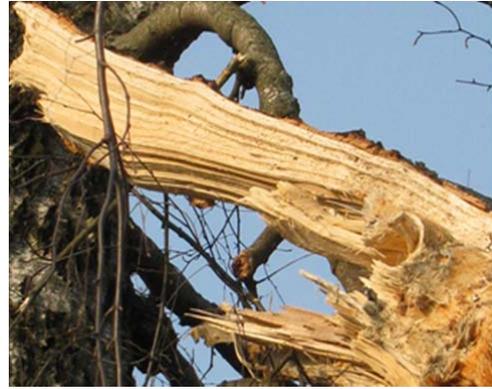
According to computer simulations, the birch tree could not cut off the left wing; (Prof. W. Binienda). The birch tree was already broken before the crash. (Prof. C. Cieszewski).⁷⁴

[21] The birch tree that allegedly cut off the wing. Source: J. Gruszczyński, C. Cieszewski

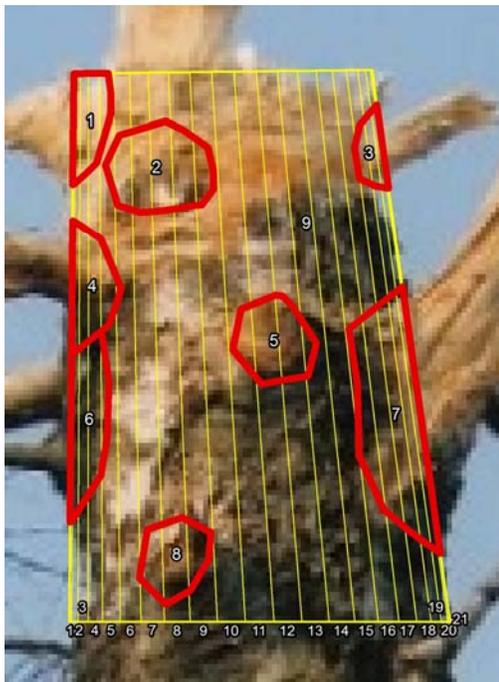
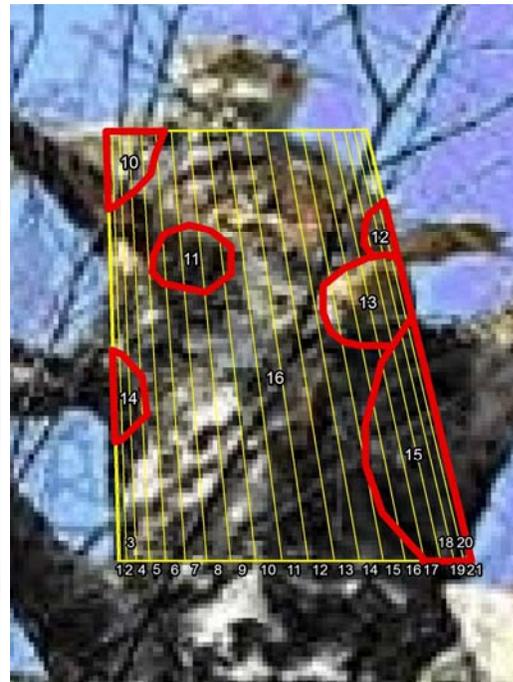
[22] Strength of the birch tree reduced due to numerous knots. Source: C. Cieszewski.

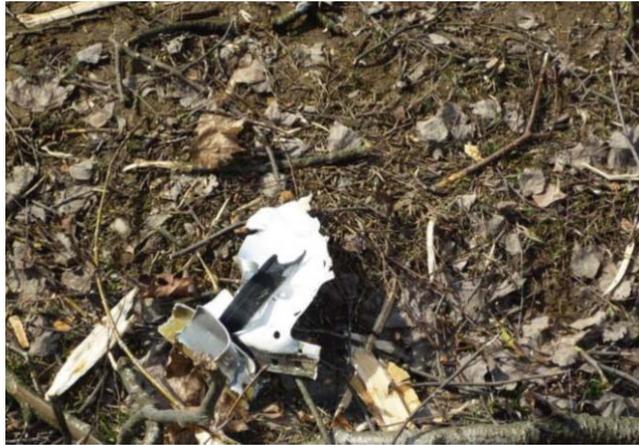
The wreckage of the plane, shape of debris and conditions of the bodies point to explosion in mid air. (G. Szuladzinski, J. Obrębski, S. Zagrodzki).

[23] A piece of debris characteristic of explosion; Source: Analytical Services Pty Ltd

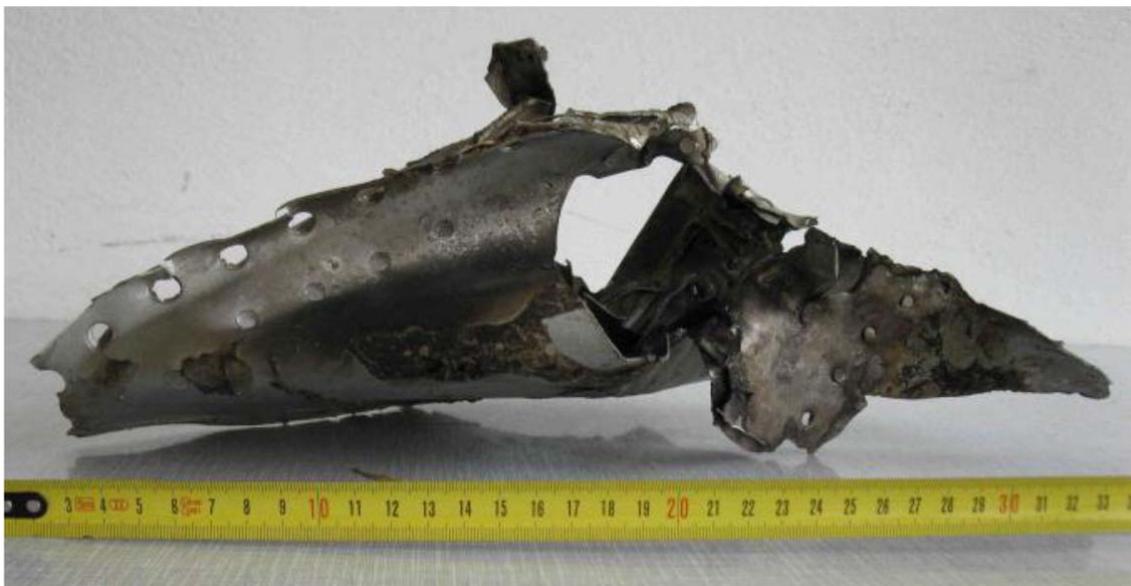
[24] A piece of debris showing signs of explosion; Source: Prof. J Obrębski.

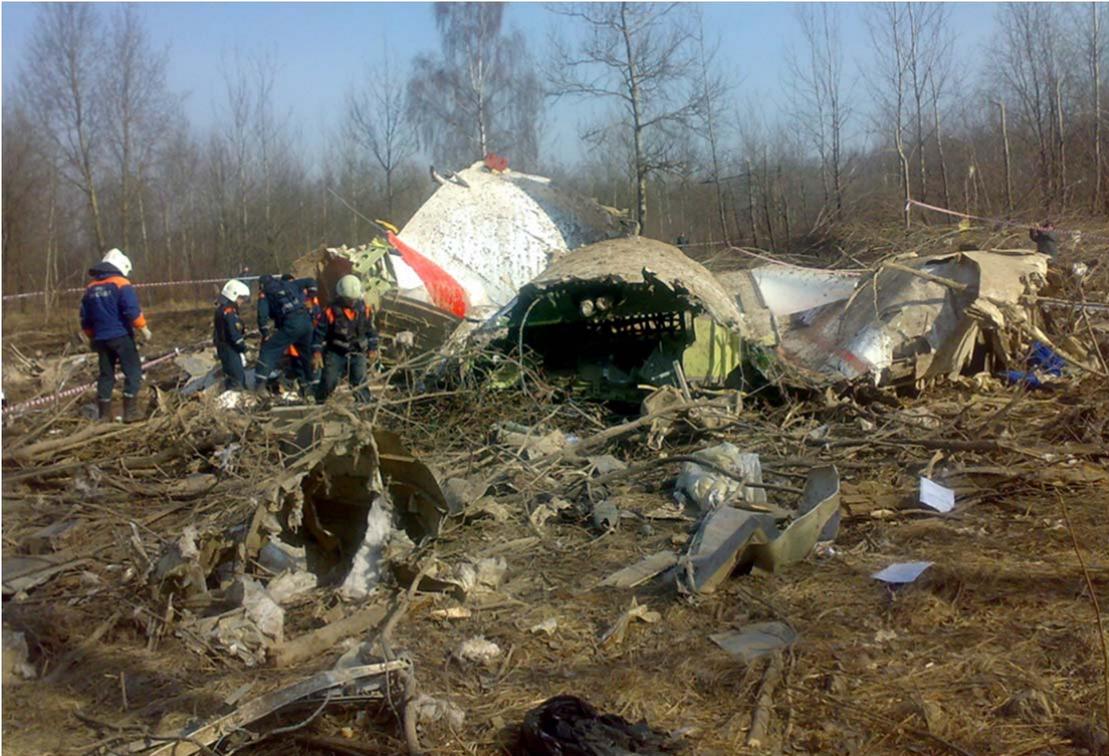
Finally, a self-evident photograph showing a large part of the fuselage at the crash site proves beyond a reasonable doubt that the fuselage first opened up in the air, then inverted in the air, and hit the ground in the inverted position. Thus, the wreckage fell to the ground inverted with both side walls of the fuselage bent outside. One wall of the fuselage was turned outside to the left of the fuselage and the other wall was outside to

the right. According to Prof. W. Binienda, this configuration of the fuselage at the crash site is only possible as a result of explosion in mid-air.⁷⁶

[25] A part of the fuselage inverted and opened up. Source: Polish Parliamentary Committee

The fuselage burst into many pieces. The front parts of the fuselage and the cockpit were not inverted while rear parts of the fuselage were found in the inverted position. All cargo was blown away from the cargo space. Gears were in revers position. All passenger seats disintegrated into pieces and the bodies of the victims were either found in small pieces, or without external clothing, or not found at all. The evidence points out to several explosions in mid-air at a low altitude as the only explanation of the type of damage documented at the crash site.
